CASE STUDY:

Water Loss Mitigation for Calistoga Unified School District

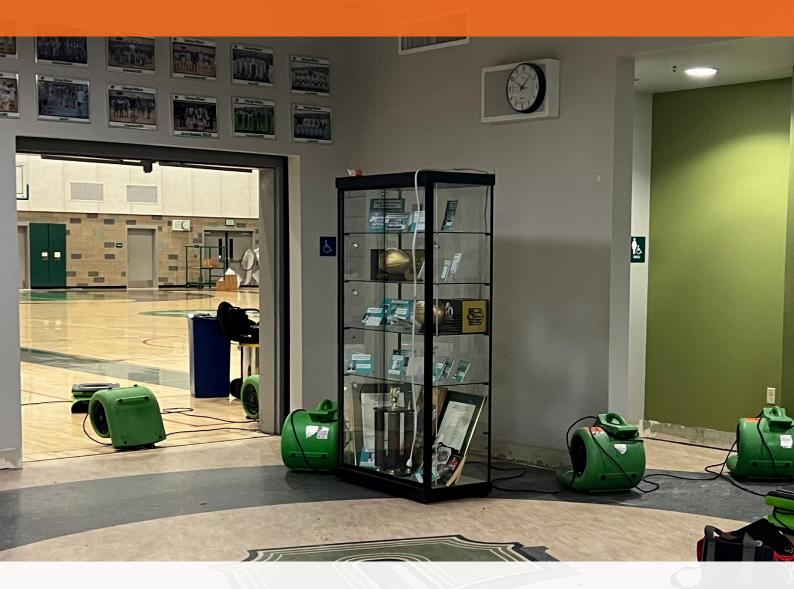
In early 2023, a significant water loss incident occurred at the Calistoga Unified School District, primarily affecting the gym building, including the basketball court, kitchen, and several bathrooms. The issue stemmed from a malfunction in the supply line to the sprinkler system, resulting in extensive water damage that threatened the integrity of the school's facilities.

West Coast Fire & Water's 24/7 Rapid Response Team was deployed to the scene on the same evening the incident was reported, arriving promptly at 7 PM. Upon assessment, the team initiated emergency procedures, which included the following steps.

The ceiling was carefully demolished to access the water-damaged areas, and flood cuts were made on the drywall to allow for effective drying of the insulation.

To facilitate thorough drying, desiccant dehumidifiers were installed that night. These units ran continuously for 12 to 14 days to ensure complete moisture removal, particularly beneath the basketball court floorboards, where moisture could lead to mold growth if left unaddressed.
