CASE STUDY: Storm Damage at St. Helena School

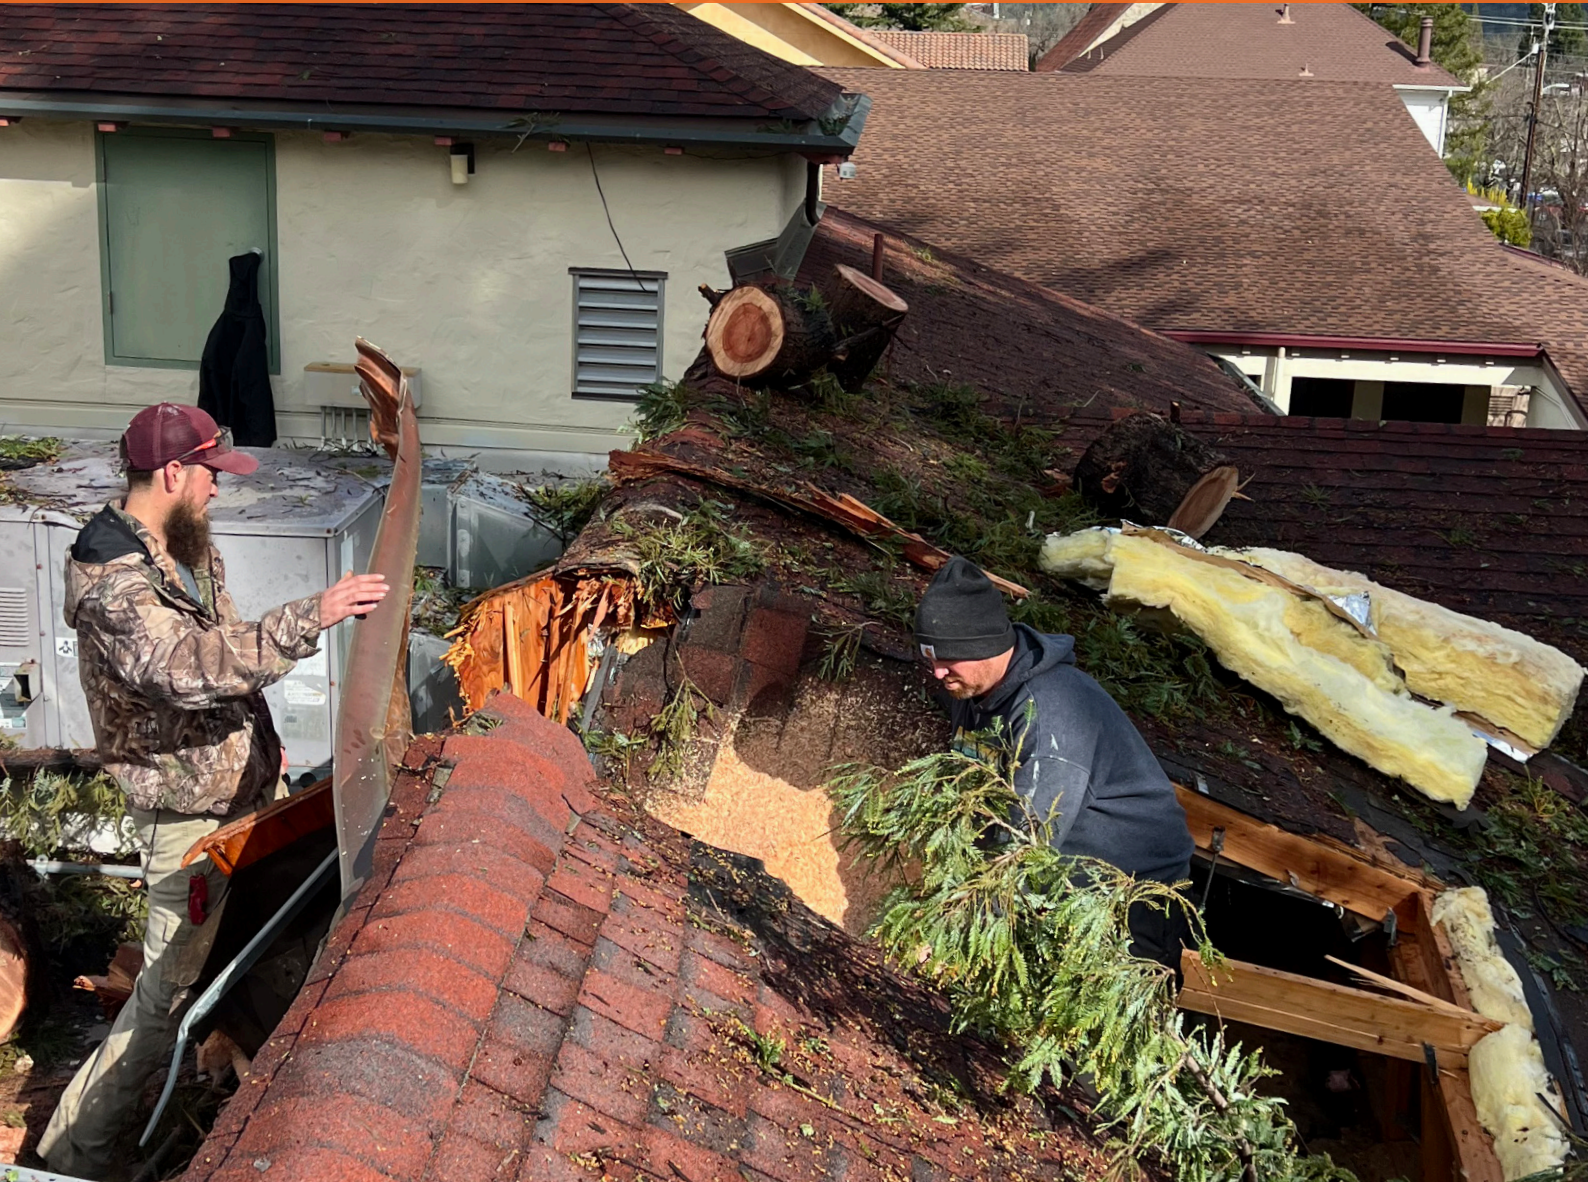
In the aftermath of a severe storm, a tree fell on the roof of St. Helena School, causing significant damage to the facility. An immediate response was necessary to extract water, place dehumidifiers, and limit the spread of damage.

The school faced a large loss, with extensive contents affected, walls damaged, and standing water present on the gym floor, both on top and underneath the surface. Swift action was required to prevent further deterioration and prepare the school for repairs.

The team first extracted any remaining water from the affected areas. A roof tarp was installed to cover the opening created by the fallen tree, preventing additional water intrusion.

The standing water was mopped up, and three desiccant dehumidifiers were deployed to aid in the drying process. This helped to stabilize the environment within the school while preventing further damage to building materials.

West Coast collaborated with the school district to strategize the removal of contents from affected areas to make way for the demolition process. Within a couple of days, the demolition was completed, allowing for effective drying of all necessary building materials.

To salvage the gym floor, the team removed the baseboards around its perimeter and utilized air movers to blow hot dry air beneath the surface, facilitating thorough drying without compromising the flooring.
